NASA Contractor Report 3816

Advanced Composite Vertical Fin  
for L-1011 Aircraft

*Design, Manufacture, and Test  
(Executive Summary)*

A. C. Jackson  
*Lockheed-California Company  
Burbank, California*

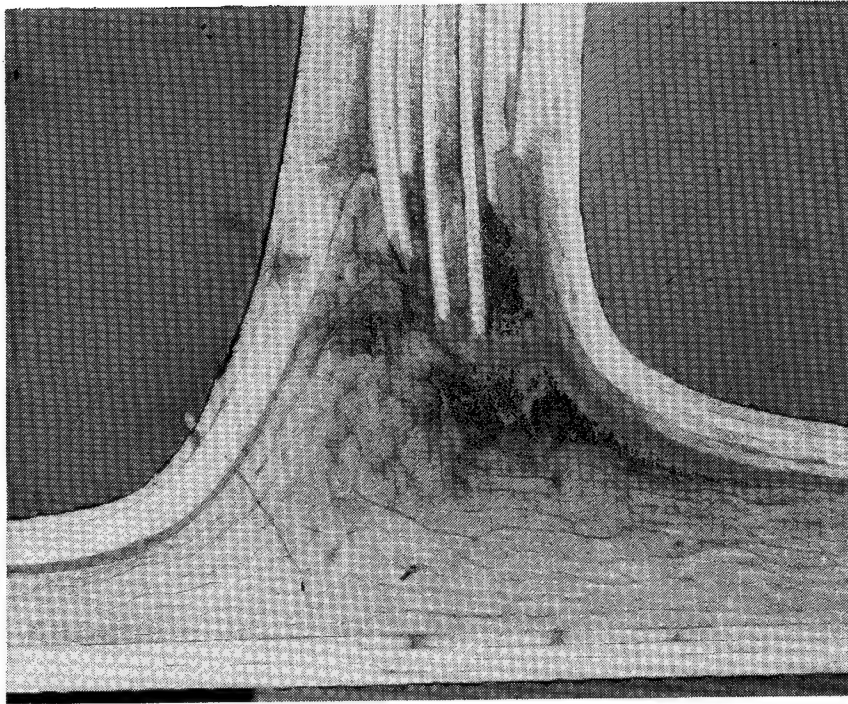
Figure 29. - Photomicrograph of section from GTA No. 1 front spar cap, right side at VSS 278.3.

The first static test resulted in an unexpected failure at 98 percent Design Ultimate Load (DUL). Following an investigation into the cause of the failure, a second ACVF (GTA No. 2) was reinforced and the test program continued. The following is an account of the failure analysis of GTA No. 1, reinforcement of GTA No. 2 and the subsequent testing of GTA No. 2.

As a result of the ground test some redesign would be necessary before the fin could be committed to production. A redesign of the spar would include taking all the web plies around into the cap, and the cap would be designed for specified out-of-plane loading. Figure 30 shows a schematic of the original cap and the redesigned cap. It is estimated that a redesign of the spars would add about 15 lbs. This would be due to thicker spar caps when all the web plies are continued into the cap flanges, the elimination of the lower six access holes in the front spar web and the replacement of the front

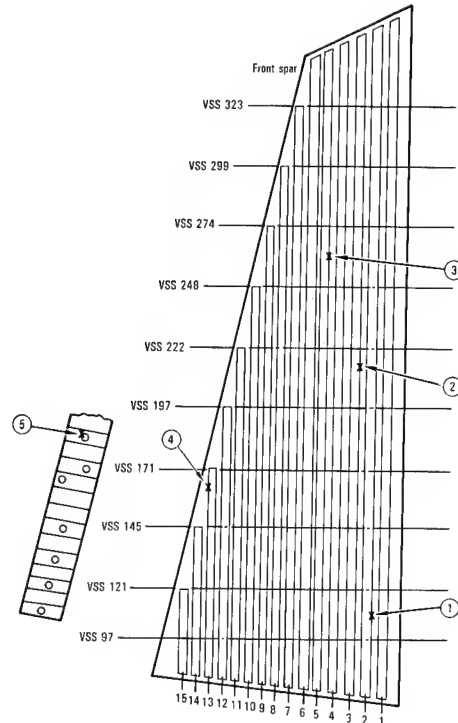
Figure 34. - Impact damage locations.

Impact No. 2 was in the 14-ply skin area. Four impacts were required to obtain visible damage. The first impact was at 13.33 ft-lb. Some damage was evident ultrasonically. A second impact at 8.64 ft-lb showed no evidence of change ultrasonically. A third impact, now back at 13.33 ft-lb, gave no visible damage but increased the damage area determined ultrasonically. A fourth impact was made, but at an energy level of 18.95 ft-lb. Visible penetration through the thickness occurred.

Impact No. 3 was in the 10-ply skin area. This area was impacted at 13.33 ft-lb also. One impact caused visible surface damage.

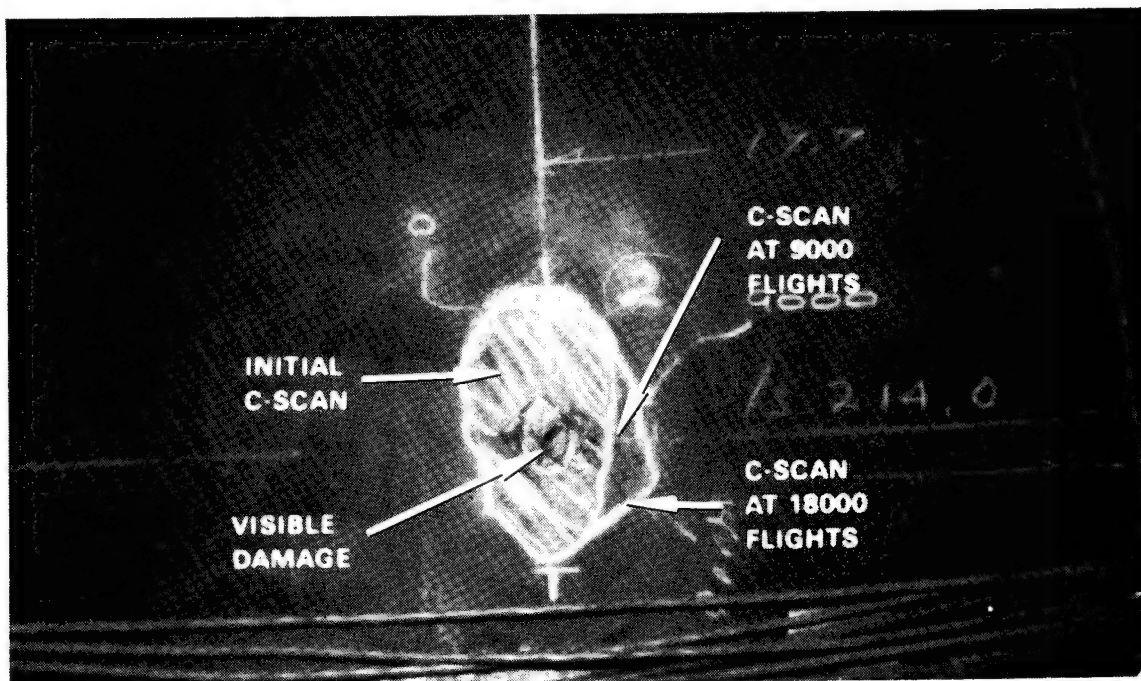
Figure 35. - Impact No. 2 damage growth.

At the completion of each one-quarter lifetime (9000 flights) of fatigue loading the impacted areas were inspected ultrasonically and damage growth, if any, marked on the part. The damage and growth for impact No. 2 shown in figure 35 is typical of that which occurred at all five locations. Most growth occurred during the first half lifetime of fatigue cycling and could only be determined ultrasonically.

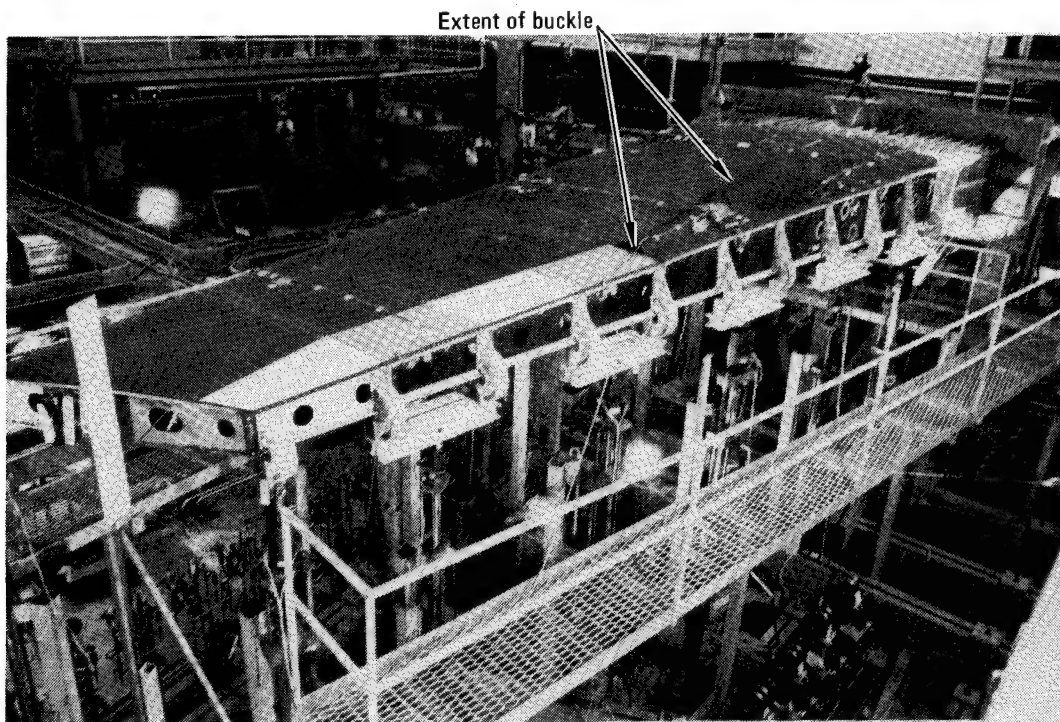
Figure 38. - Fin box at the moment of failure.

The initial failure was caused by high interlaminar stresses induced by shear buckling of the trapezoidal skin panel between VSS 222 and VSS 248 and between the front spar and stiffener No. 10. The high speed film showed that the skin buckled up just above VSS 222 and the buckle then propagated outboard and inboard as the skin and stiffener separated. Shear buckling was measured by a pair of back-to-back shear rosettes in the bay below VSS 222. The strain gage plots shown in figure 39 indicate that shear buckling initiated at about

design limit load. The Poisson-induced lateral compression strain combined with the shear caused the initial buckling and proved to be more severe than the axial compression and shear on the other cover which did not buckle until 80 percent DUL.
